INVESTIGATION OF ASPHALT PAVEMENT RUTTING AT TWO CANADIAN AIRFIELDS

M. Wensel^A, A. Shalaby^A, M. Thiessen^B, V. Mah^B

ABSTRACT: Rutting is the permanent deformation of pavement layers which can accumulate over time. Highway rutting is common due to high channelization and higher repetition traffic. On airfield pavements, rutting is less prevalent because of the lower number of repetitions of aircraft traffic and less lane restrictions. Some of the common causes of airfield rutting are jet fuel spills, jet blast, high tire pressures, asphalt strength and flow characteristics, aircraft loading repetitions and environmental conditions. In the past five years, two Canadian air force bases, CFB Goosebay and Cold Lake, have experienced extensive rutting on some of the slower traffic areas, which have been in operation for over ten years. The affected areas are classified as taxiways, holding areas, touch-down areas, and run-up pads. The primary users of these pavement areas are fighter jet planes, for which potential ruts, sharp pavement edges and Foreign Object Debris (FOD) can cause substantial damage to aircraft tires, turbine engine and fuselage.

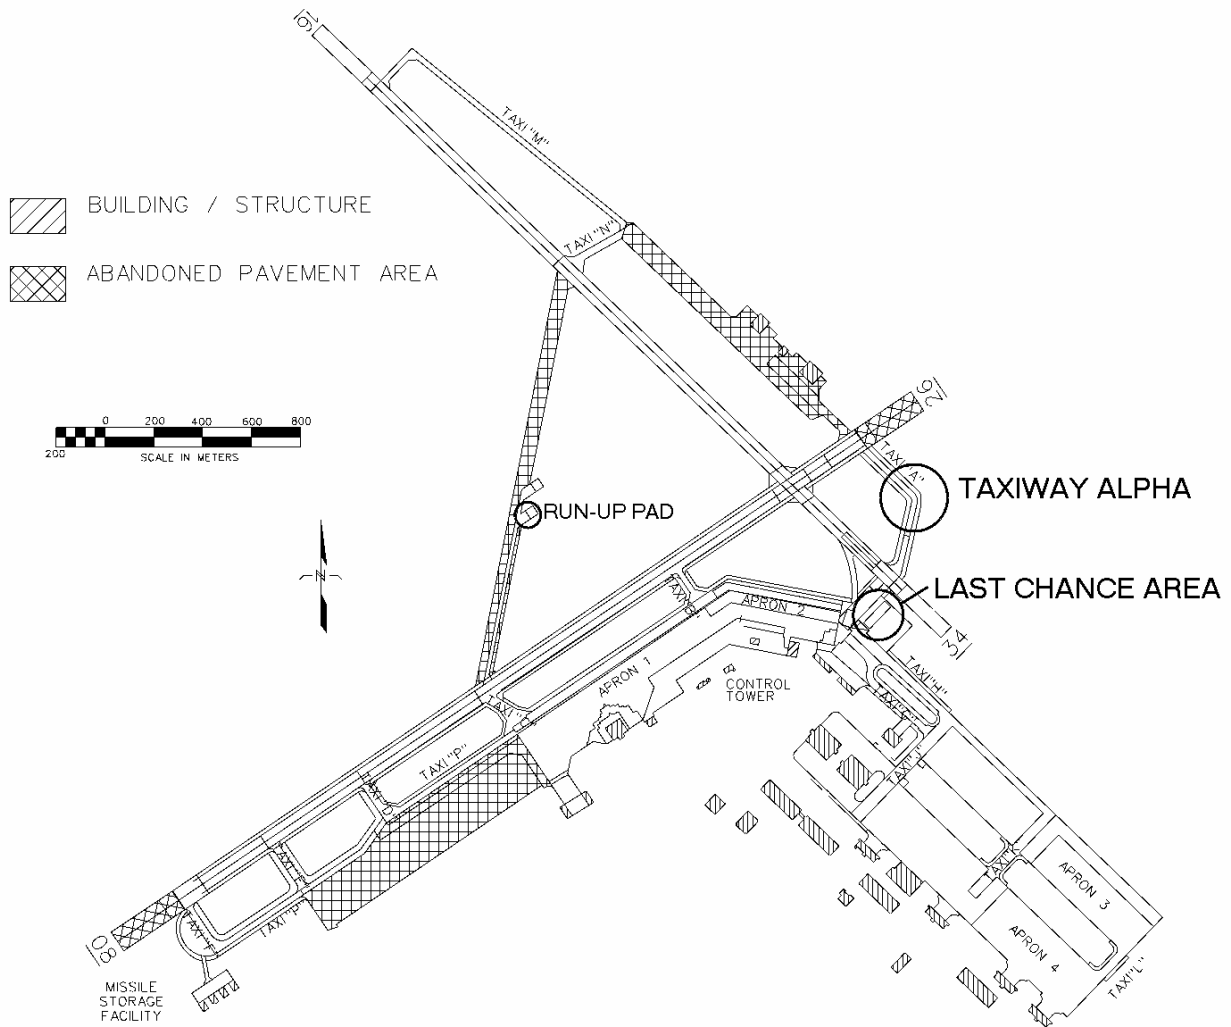
Figure 1: Locations of Rutted Pavement Sections at CFB Goosebay

CFB Goosebay is located in Labrador in north-eastern Canada. The airfield is used primarily as a training facility for the fighter squadrons of the allied forces, and as such, the pavements are subjected to high levels of jet traffic. The air temperatures experienced in this region reach an average maximum of 30.9°C and a minimum of -29.4°C, the pavement temperatures vary from a high of 42.9°C to a low -28.9°C as indicated in the weather station records stored in the LTPPBind software database (LTPPBind, 2000). The pavement sections affected at this base are Taxiway Alpha, the Last Chance Area, and the Run-Up Pad as shown in Figure 1.

The rutting of the pavement is occurring primarily in the northbound lane of the taxiway over an approximate area of 4,600m², which encompasses the bend in the taxiway. In addition to rutting distresses, this area of the taxiway has a significant amount of rippling and patching in the rutted lane, but minimal surface cracking.

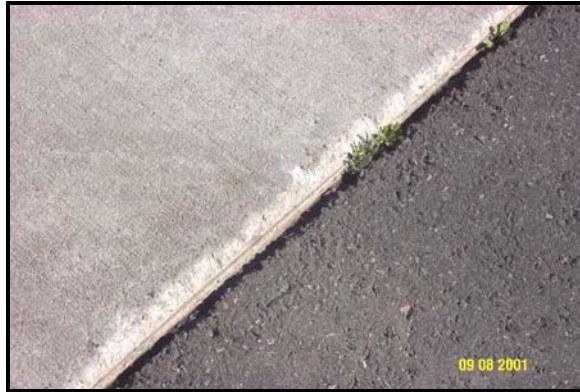
The rutting of this area is occurring mainly at the interface of the two pavement types on all eight of the pads, although, the pads located closer to the runway are experiencing a higher degree of rutting due to their more frequent use. The surface distresses observed are more severe on the northern portion of the HMAC slab, but the southern half is also experiencing significant cracking. Another significant distress is the loss of the joint sealant at the interface of the HMAC and PCC. Because of the rutting, the joint sealant is being pulled away by the separating joint permitting water infiltration and vegetation growth as seen in Figure 2.

Figure 2: Vegetation Growth at the Interface

Two of the three affected areas, Last Chance Area and Run-up Pad, are located at an interface of concrete and asphalt pavements with wheel loads travelling across the joint. The edge loading conditions are the main cause of rutting in these areas. It is reasonable to assume that this rutting is caused by lack of structural support to the pavement. The maximum tire pressure experienced by these pavements is from the Tornado jet fighters, with a 2.07 MPa pressure.

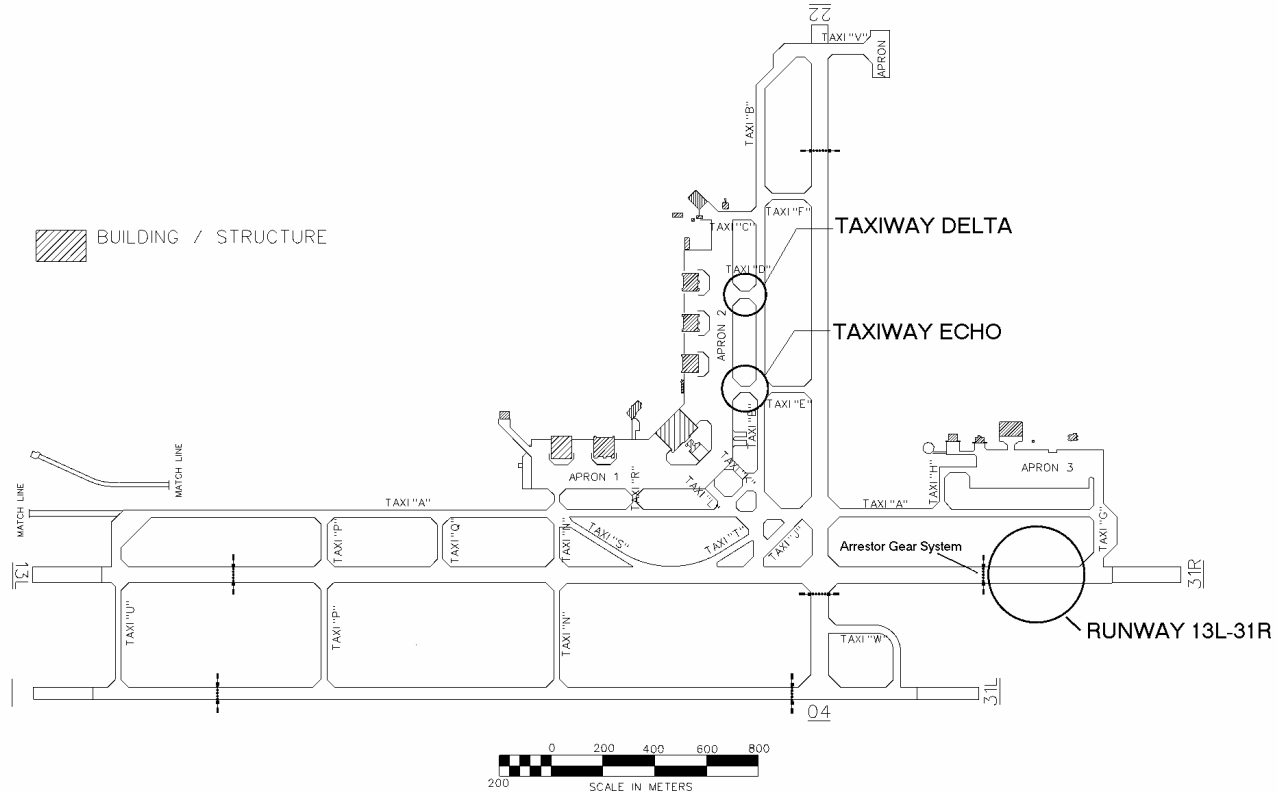
Figure 3: Locations of Rutted Pavement Sections at CFB Cold Lake

(LTPPBind, 2000). As show in Figure 3, the affected pavements at this base include taxiways Delta and Echo and the touch-down area of Runway 13L-31R.

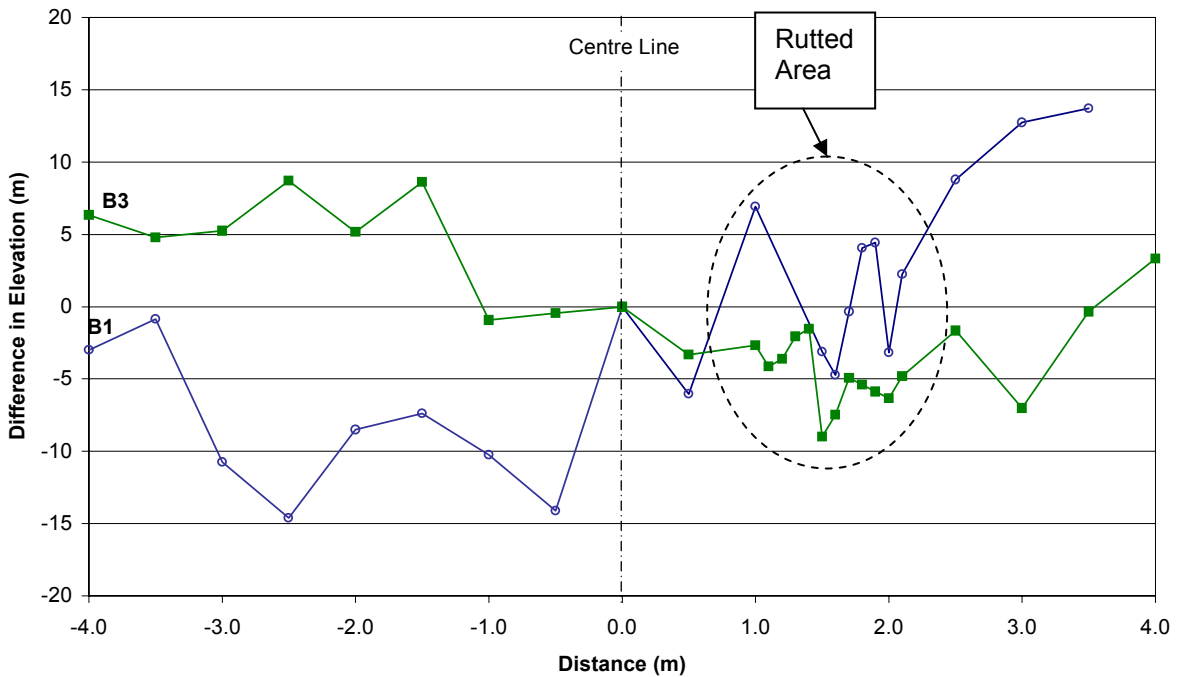
For the three sections of concern, a total of 29 cross-sections were surveyed and 57 core samples taken. Two sample rotated cross-sections are shown below in Figure 4; for taxiway alpha, showing both the first 4m on the left and right lanes of the centreline. The sample data shown are for the first and third cross-sections of the pavement area, which was labelled as “B” for the study. The rutting distresses appear to be more severe on the right side of the centreline. The cross-section data was analyzed to determine the rut depths using a 1.8m straight edge simulation and the extent of rutting is shown in Table 3.

Figure 4: Sample Cross-Sections for Taxiway Alpha

LOCATION	RUT DEPTH (mm)		
	Minimum	Average	Maximum
Taxiway Alpha	4	8	17
Last Chance Area	2	12	28
Run-up Pad	5	8	19

Taxiway Alpha is experiencing mix instability which is causing shoving to occur along the curve in the taxiway. Slow-moving aircraft, stop-and-go movements and sharp turns have caused rippling and rutting on the asphalt pavement surfaces on the taxiway. The maximum tire pressure experienced by the taxiway is from the Tornado jets with a 2.07 MPa pressure.

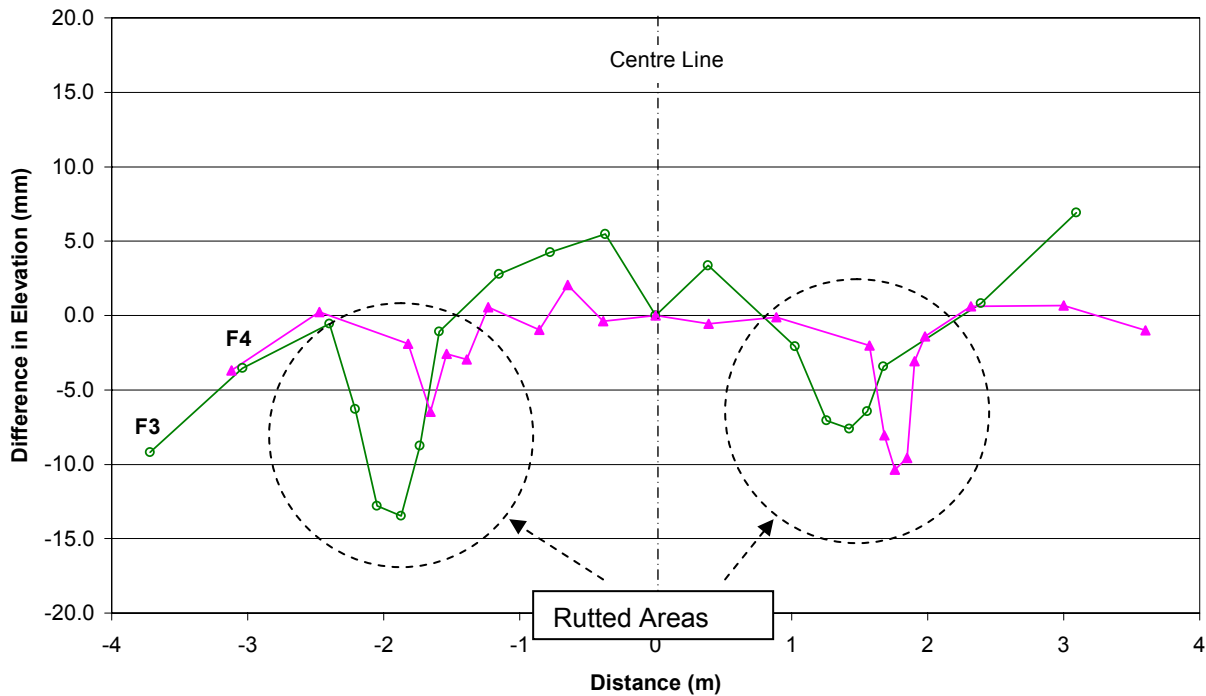
For the three affected areas, a total of 24 cross-sections were surveyed and 40 core samples taken. Two sample rotated cross-sections from the base are shown in Figure 5; for runway 13L-31R, showing 4m to the left and right of centre. The sample data shown is for the third and fourth cross-sections of the pavement area which was labelled “F” for the study. As can be seen in the figure there appears to be rutting distresses on both the left and right side of centre. The rut depths found for each section through analysis of the collected cross-section data are shown in Table 4.

Figure 5: Sample Cross-Sections for Runway 13L-31R

LOCATION	RUT DEPTH (mm)		
	Minimum	Average	Maximum
Taxiway Delta	2	9	19
Taxiway Echo	3	5	12
Runway 13L-31R	3	6	14

The touchdown zone of Runway 13L-31R experiences high impact loads and exposure to jet blasts, which are contributing to the observed rutting patterns. The pavement is subjected to dynamic loads from the aircraft landing as well as intense heat from aircraft jets causing the softening of the asphalt mix. The highest tire pressure on this runway is from F-18 fighter jets at 1.38 MPa.
