Glenlea Telescope Inspection & Repair

(picture notes for future reference)

Peiqing Wang

12/20/2018

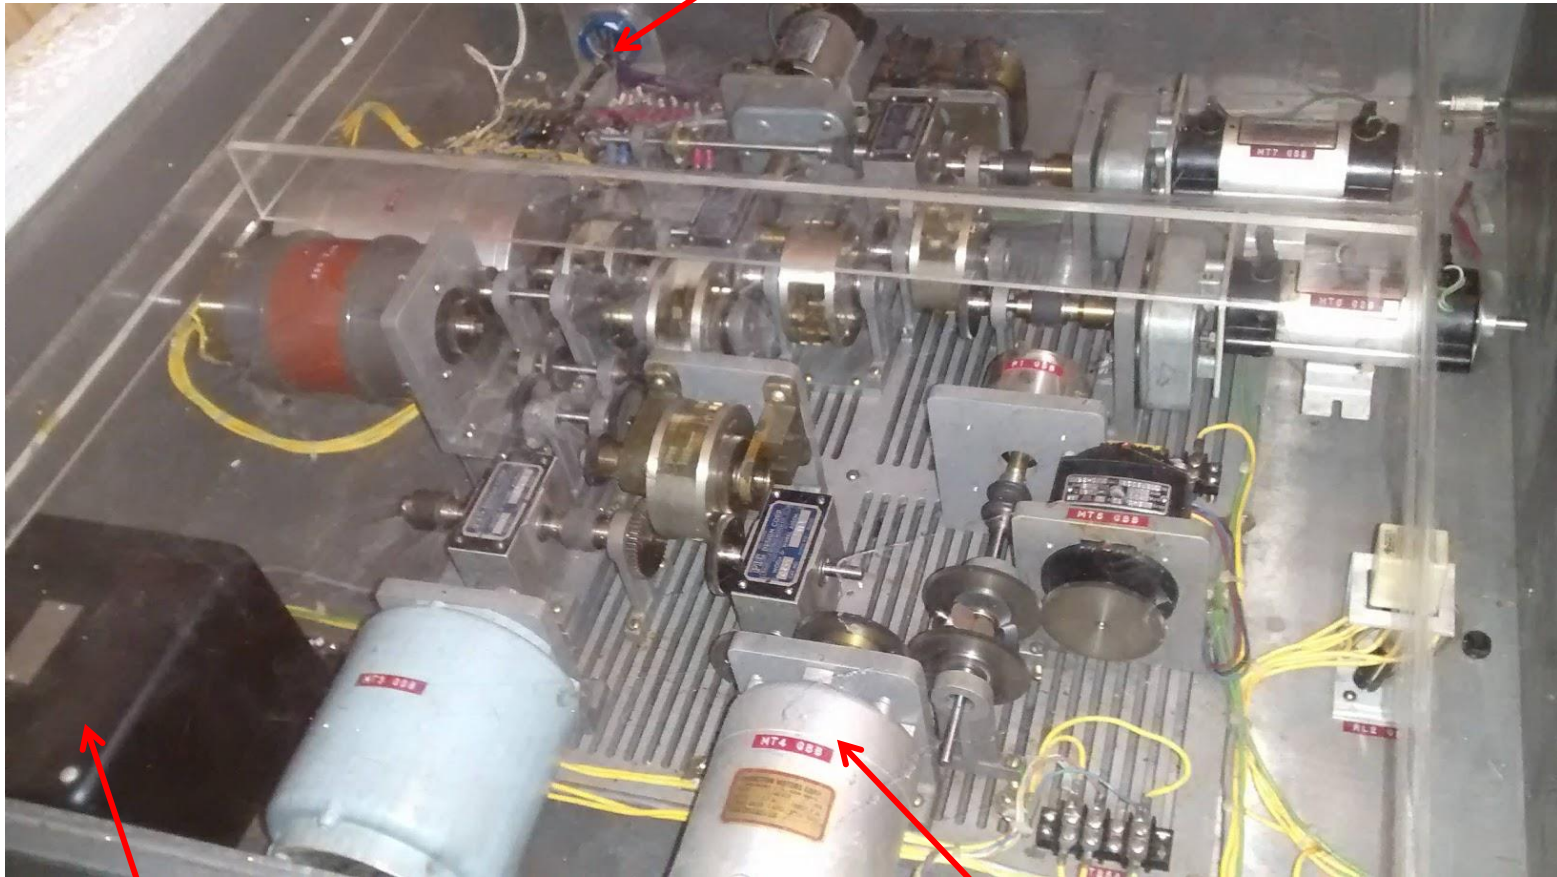
Gear box #1 in the warm control room

AC power feedthrough, and main tracking signals (sync. Rotation/angle)

DC power supply, containing a transformer, capacitors, etc.

Main motor, for generating tracking signals, turned on by the key switch inside dome

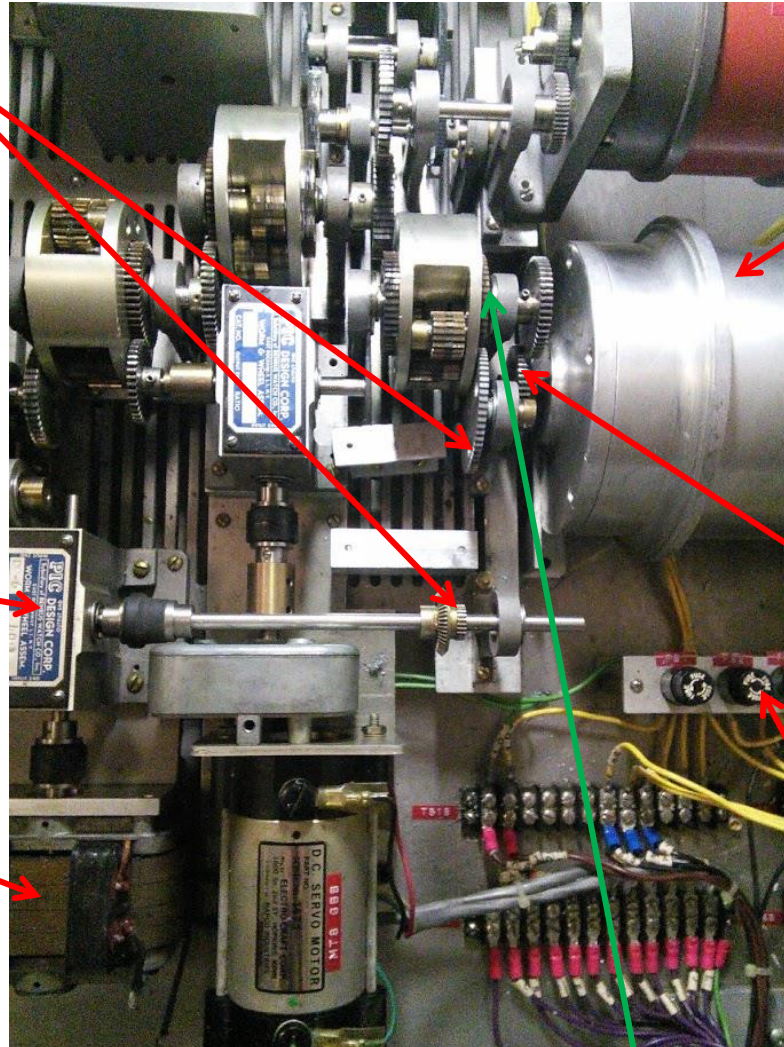
Gap and mounting brackets were found in between, suspecting there are missing parts (gears)

40:1 ratio worm gear box

Correction/fine-tune motor (no electrical connections)

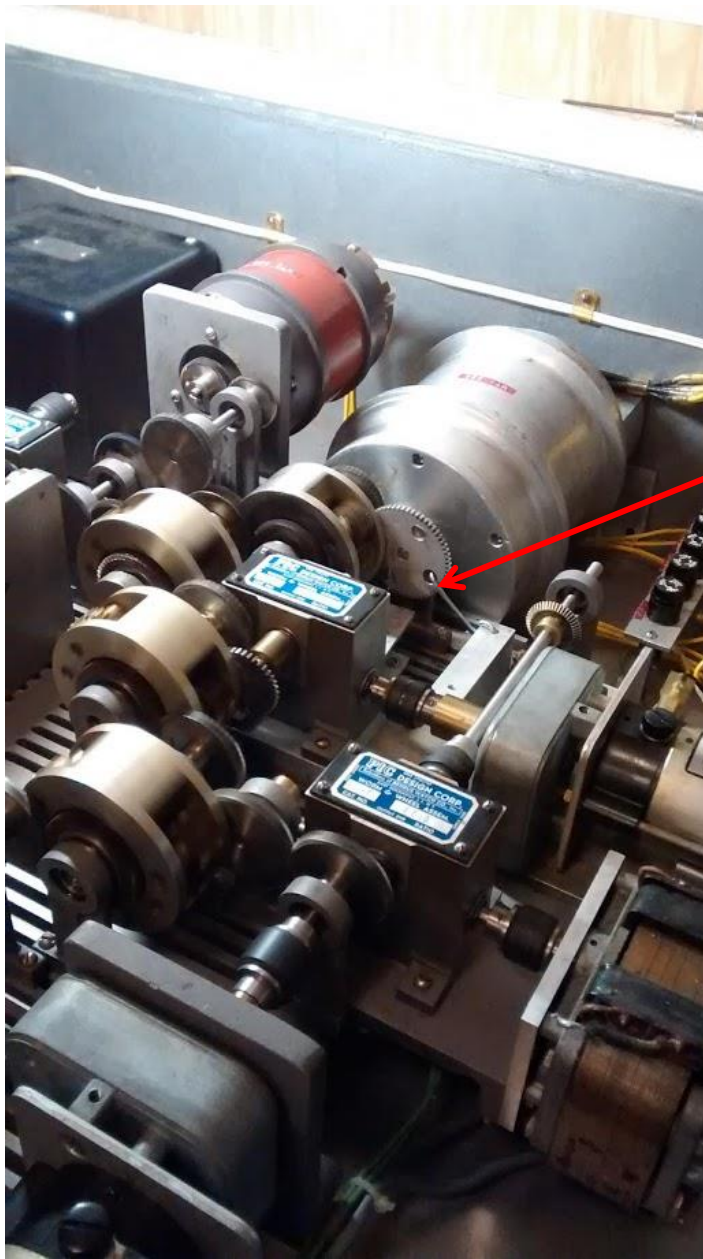
Synchro generator
110V rotor (R1,R2)
3 Phases (S1,S2,S3)

Rotor wasn't
activated hence no
tracking signals
sent to W/E gear
box in the dome

Missing fuse,
inserted a 2A fuse

No locking for this gear, thus no motion transported to the rotor of synchro generator

Temporary fix:

Bypassing the fine-tune mechanism and locking the gear with a piece of steel wire.

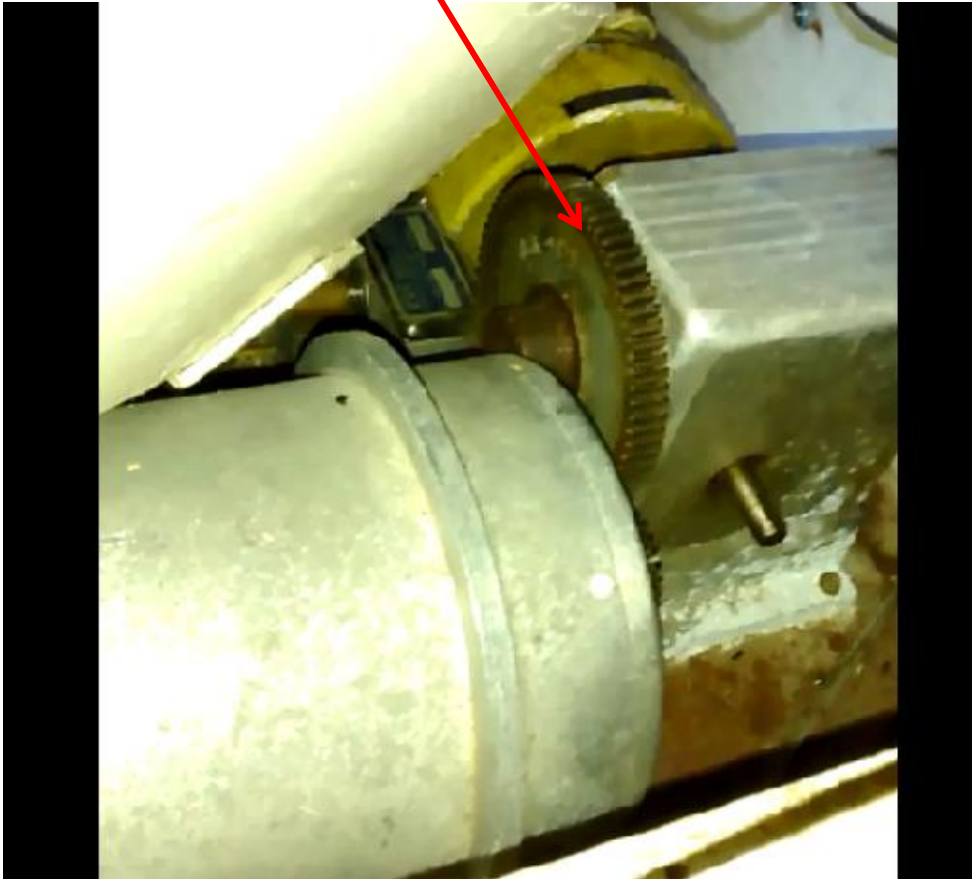
1. Turned on the key switch, the main tracking gear started motion

(the main tracking gear is located at the left hand corner of the W-E gear box under the telescope)
