RECYCLING OF SHREDDED RUBBER TIRES AS ROAD BASE IN MANITOBA: A CASE STUDY

Riaz Ahmed Khan, Graduate Student, University of Manitoba, Winnipeg, Manitoba
 Ahmed Shalaby, Assistant Professor, University of Manitoba, Winnipeg, Manitoba

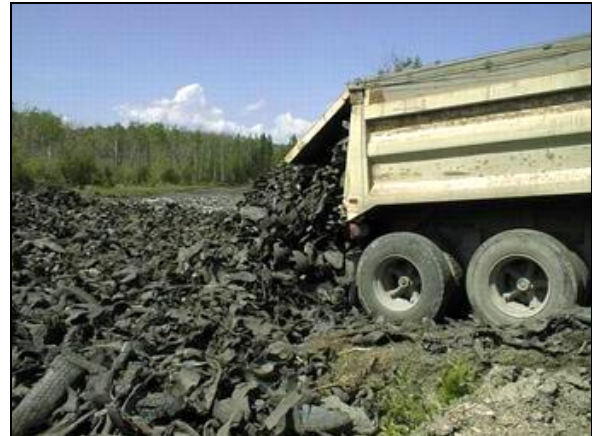
Fig 2. Delivery of shredded tires to construction site

The 300 m long road embankment was constructed in 2000. Initially five layers of tire sidewalls were manually placed on the subgrade in an overlapping pattern. Then 300 mm tire shreds were hauled to the site and were unloaded directly over the sidewalls, Fig 2. The tire shreds were spread to the desired thickness with the backhoe and then gravel was placed on top of the embankment, Fig 3. Approximately 300,000 passenger car tire equivalents were used in the construction, or one-third of

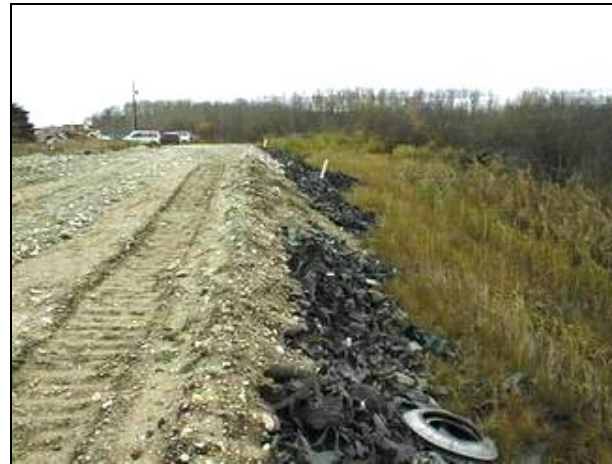
Fig 3. Tire road embankment during construction

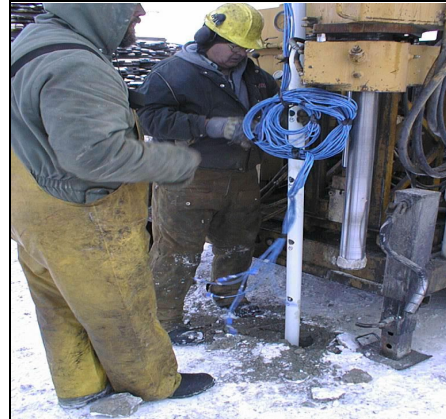
Fig 5. Installation of Thermocouple strings

Strings of thermocouples were attached to 50 mm PVC pipe casings. The thermocouple strings were 3 m long. The gaps between the thermocouples and top and bottom of the pipes were sealed using high quality sealing compound. Nine thermocouples @ 343 mm c/c and seven thermocouples @ 457 mm c/c spacing were placed in the tire road and in the ground adjacent to the tire road respectively, as shown in Fig 5. The thirty-two thermocouples were connected to the DAQ system as shown in Figure 6. The box was completely insulated using Styrofoam insulating sheets. An electric heater was placed to maintain a temperature in the range of (10-25) °C inside the box.

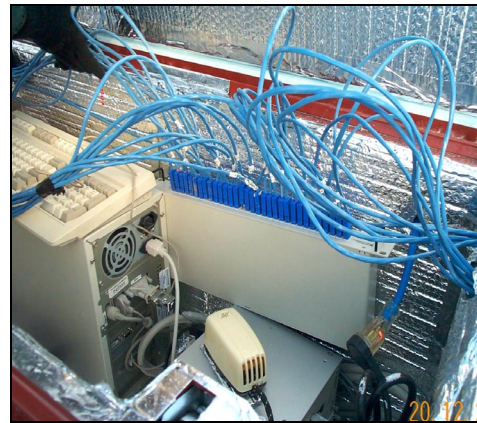
Figure 6. DAQ system

A temperature-monitoring program was started in November 2000 for the evaluation of thermal behavior of shredded tires. Ground temperature was measured by means of thermocouple sensors connected to a computer and Data Acquisition System (DAQ) located on site. The system has 16 bit analog inputs, signal amplification and cold junction compensation to provide accurate temperature measurement up to 0.1°C.

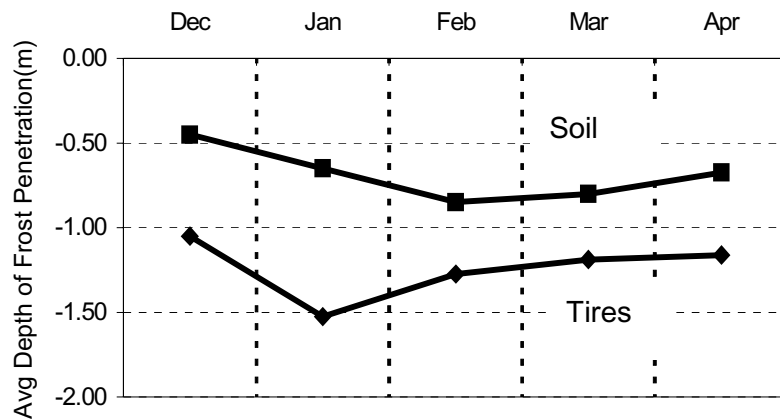
Figure 7. Average Depth of Frost Penetration during 2000-2001

The average depth of frost penetration is summarized in Fig 7. It is seen that depth of frost penetration beneath the tire road ranged from 1050 mm to 1525 mm. In contrast, in natural ground, the depth of frost penetration ranged from 450 mm to 850 mm. One reason for greater depth of frost penetration in tire road compared to the natural ground is the presence of more thicker blanket of snow on top of the natural ground compared to the tire road as the effectiveness of insulation of soil increases as thickness of overlying snow cover increases (Highway Research Board, 1952). Other reason is the presence of large voids in the tire road embankment.

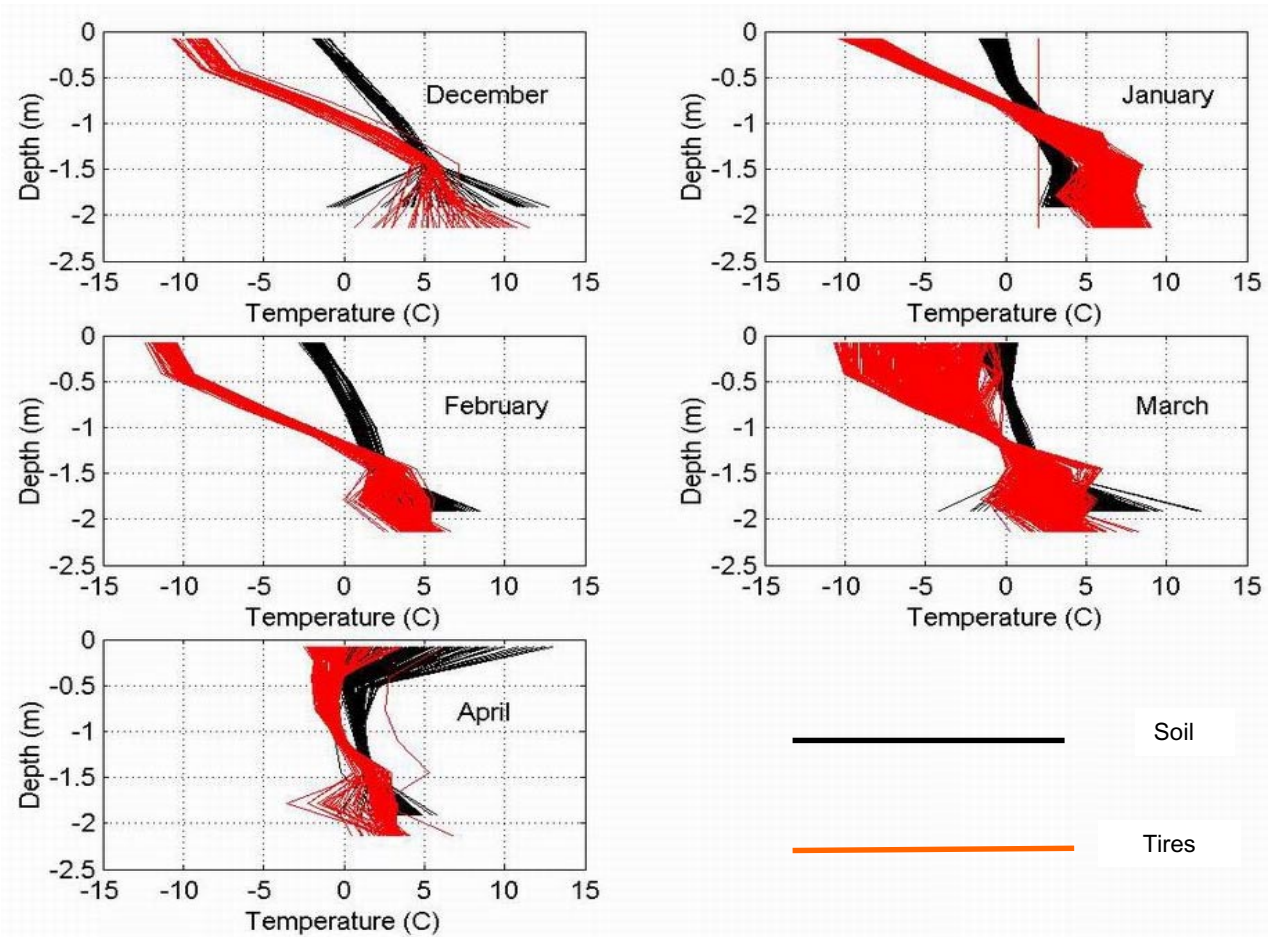
Figure 8. Thermal gradient in soil and tires

Figure 8 shows the thermal gradient of soil and tires for Winter and Spring seasons. The surface temperatures in the tire road is lower than the natural ground while the base temperature is essentially the same at both sections indicating a rapid resistance to the frost within the tire shreds fill. Hence the thermal gradient of tires is more compared to the natural ground.

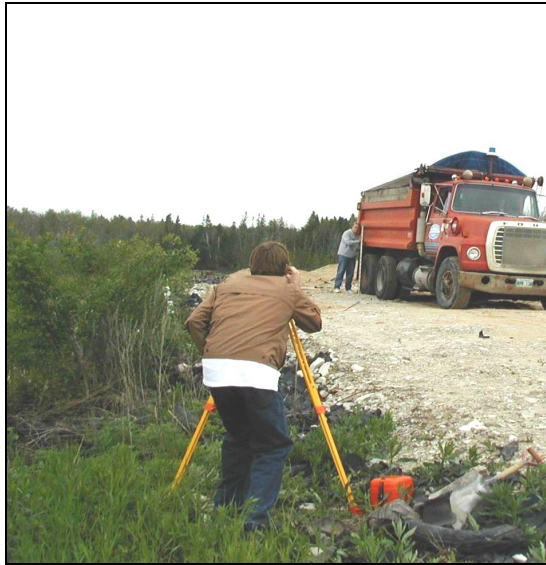
Figure 9. Deflection survey

Metal settlement plates (500x500 mm) were placed at several locations on the surface of the tire road to evaluate its compressibility. Rod and level survey was performed for this purpose in May 2001. Initially the as built elevations of the settlement plates SP1, SP2, SP3 and SP4 were recorded. Then the settlement plates were loaded by 21000 Kg dual-tandem axle load and again the elevations were recorded as shown in Fig 9. The compressibility of the road was obtained from the difference of initial and final readings. Two loading and unloading passes were performed to evaluate the compressibility of the tire road, Fig 10, which indicates an average of 15 mm and maximum of 25 mm deflections, after one year of fill placement. An average instantaneous rebound of 11 mm and an average deformation of 7 mm were also recorded after two passes of the loaded truck.

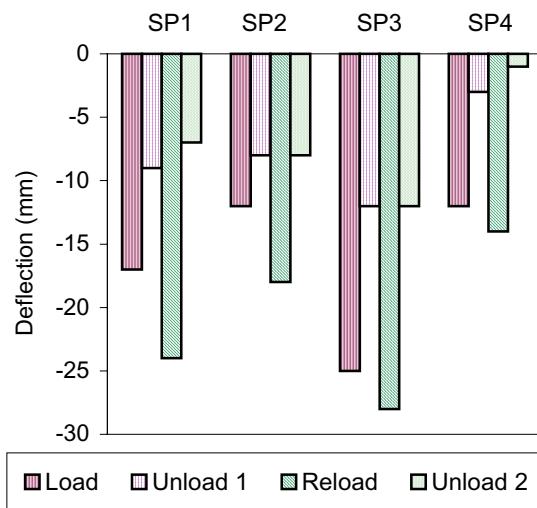
Figure 10. Surface deflections at four locations
