INVESTIGATION OF ASPHALT PAVEMENT RUTTING AT TWO CANADIAN AIRFIELDS

M. Wensel^A, A. Shalaby^A, M. Thiessen^B, V. Mah^B

ABSTRACT: Rutting is the permanent deformation of pavement layers which can accumulate over time. Highway rutting is common due to high channelization and higher repetition traffic. On airfield pavements, rutting is less prevalent because of the lower number of repetitions of aircraft traffic and less lane restrictions. Some of the common causes of airfield rutting are jet fuel spills, jet blast, high tire pressures, asphalt strength and flow characteristics, aircraft loading repetitions and environmental conditions. In the past five years, two Canadian air force bases, CFB Goosebay and Cold Lake, have experienced extensive rutting on some of the slower traffic areas, which have been in operation for over ten years. The affected areas are classified as taxiways, holding areas, touch-down areas, and run-up pads. The primary users of these pavement areas are fighter jet planes, for which potential ruts, sharp pavement edges and Foreign Object Debris (FOD) can cause substantial damage to aircraft tires, turbine engine and fuselage.

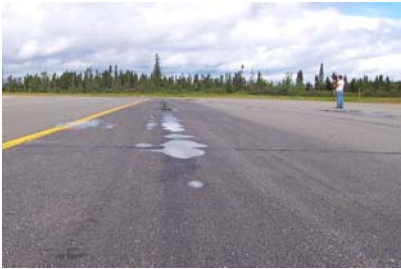
The rutting of the pavement is occurring primarily in the northbound lane of the taxiway over an approximate area of 4,600m², which encompasses the bend in the taxiway. In addition to rutting distresses, this area of the taxiway has a significant amount of rippling and patching in the rutted lane, but minimal surface cracking.

Taxiway Alpha is experiencing mix instability which is causing shoving to occur along the curve in the taxiway. Slow-moving aircraft, stop-and-go movements and sharp turns have caused rippling and rutting on the asphalt pavement surfaces on the taxiway. The maximum tire pressure experienced by the taxiway is from the Tornado jets with a 2.07 MPa pressure.

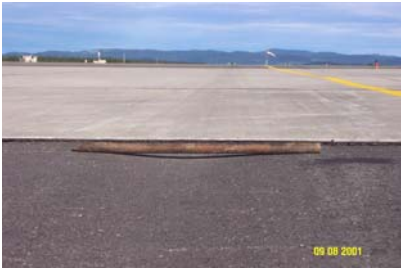
The rutting of this area is occurring mainly at the interface of the two pavement types on all eight of the pads, although, the pads located closer to the runway are experiencing a higher degree of rutting due to their more frequent use. The surface distresses observed are more severe on the northern portion of the HMAC slab, but the southern half is also experiencing significant cracking. Another significant distress is the loss of the joint sealant at the interface of the HMAC and PCC. Because of the rutting, the joint sealant is being pulled away by the separating joint permitting water infiltration and vegetation growth as seen in Figure 2.

Two of the three affected areas, Last Chance Area and Run-up Pad, are located at an interface of concrete and asphalt pavements with wheel loads travelling across the joint. The edge loading conditions are the main cause of rutting in these areas. It is reasonable to assume that this rutting is caused by lack of structural support to the pavement. The maximum tire pressure experienced by these pavements is from the Tornado jet fighters, with a 2.07 MPa pressure.

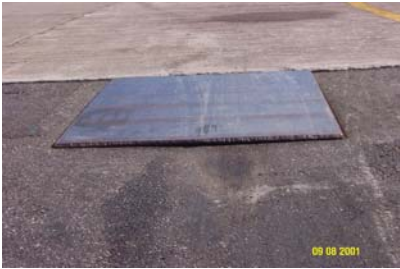
The rutting starts at the PCC and HMAC interface and extends over a length of 8m into the pad. Heavy steel plates are currently covering the most severe portions of the rutted pad. The surface of the pavement is covered with previous asphalt patches and minor fuel and oil spills. Like the Last Chance Area, the sealant between the asphalt and PCC area has detached and is showing signs of pulling out of the crack.

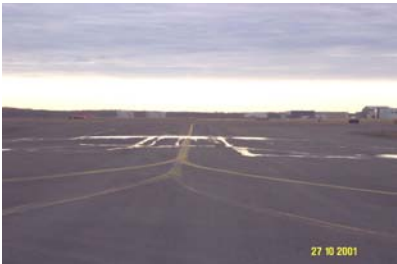
<p>27 10 2001</p>

The rutting of the HMAC is occurring on either side of the centreline generally closer to the middle of the taxiway. It has been observed by operations that aircrafts have a tendency to wait in the middle of the taxiway for clearance generally coming to a complete stop before heading to Taxiway Bravo or Apron 2. The rutted area of the taxiway was patched using cold mix in October 2000 which has caused a slight discoloration of the pavement. The repair has rutted again, but not to the same extent as previously. The rutted area is also experiencing significant cracking. Most of the cracks have broken through the sealant or have not yet been sealed.

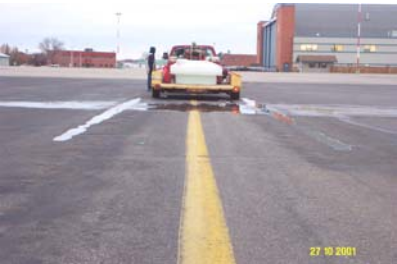
<p>27 10 2001</p>

the taxiway. The rutting is likely occurring due to the same reasons as previously mentioned with the aircrafts pausing in the middle of the taxiway for clearance or coming to a complete stop before heading to Taxiway Bravo or Apron 2. Like Delta, the rutted area on Echo was previously repaired using a cold patch in October 2000, which has caused a slight discoloration of the pavement. The repaired area is showing signs of rutting to a lesser extent than previously. The surface distresses are also significant on taxiway Echo. Most of the sealed cracks have reopened and there are newer cracks, which have not yet been sealed.

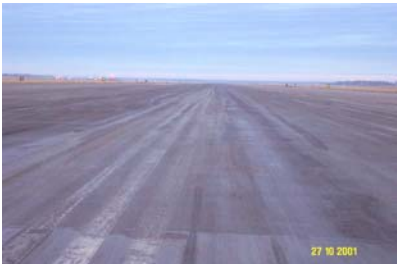
<p>27 10 2001</p>

The rutting is occurring on either side of the centreline in the middle 10m of the runway. The ruts are more prevalent closer to Button 31R and dissipate towards the arrestor gear system. There are also numerous surface distresses in the section. The pavement has experienced significant ravelling and large thermal cracks occurring at regular intervals. There are also several areas severely affected by the heat of jet blast.
